DRAWN: M.H.	TITLE: INTENSIFIER WEEP HOLE IDENTIFICATION TROUBLESHOOT GUIDE	REF. NR. -
CHECKED: H.A.		MADE FROM: -
APPRVD: H.A.		REV 0
SCALE: NTS	SIZE B	SHEET 1 OF 1
DATE: 2/10/2011	DWG. NO. 301020-3-3-HL

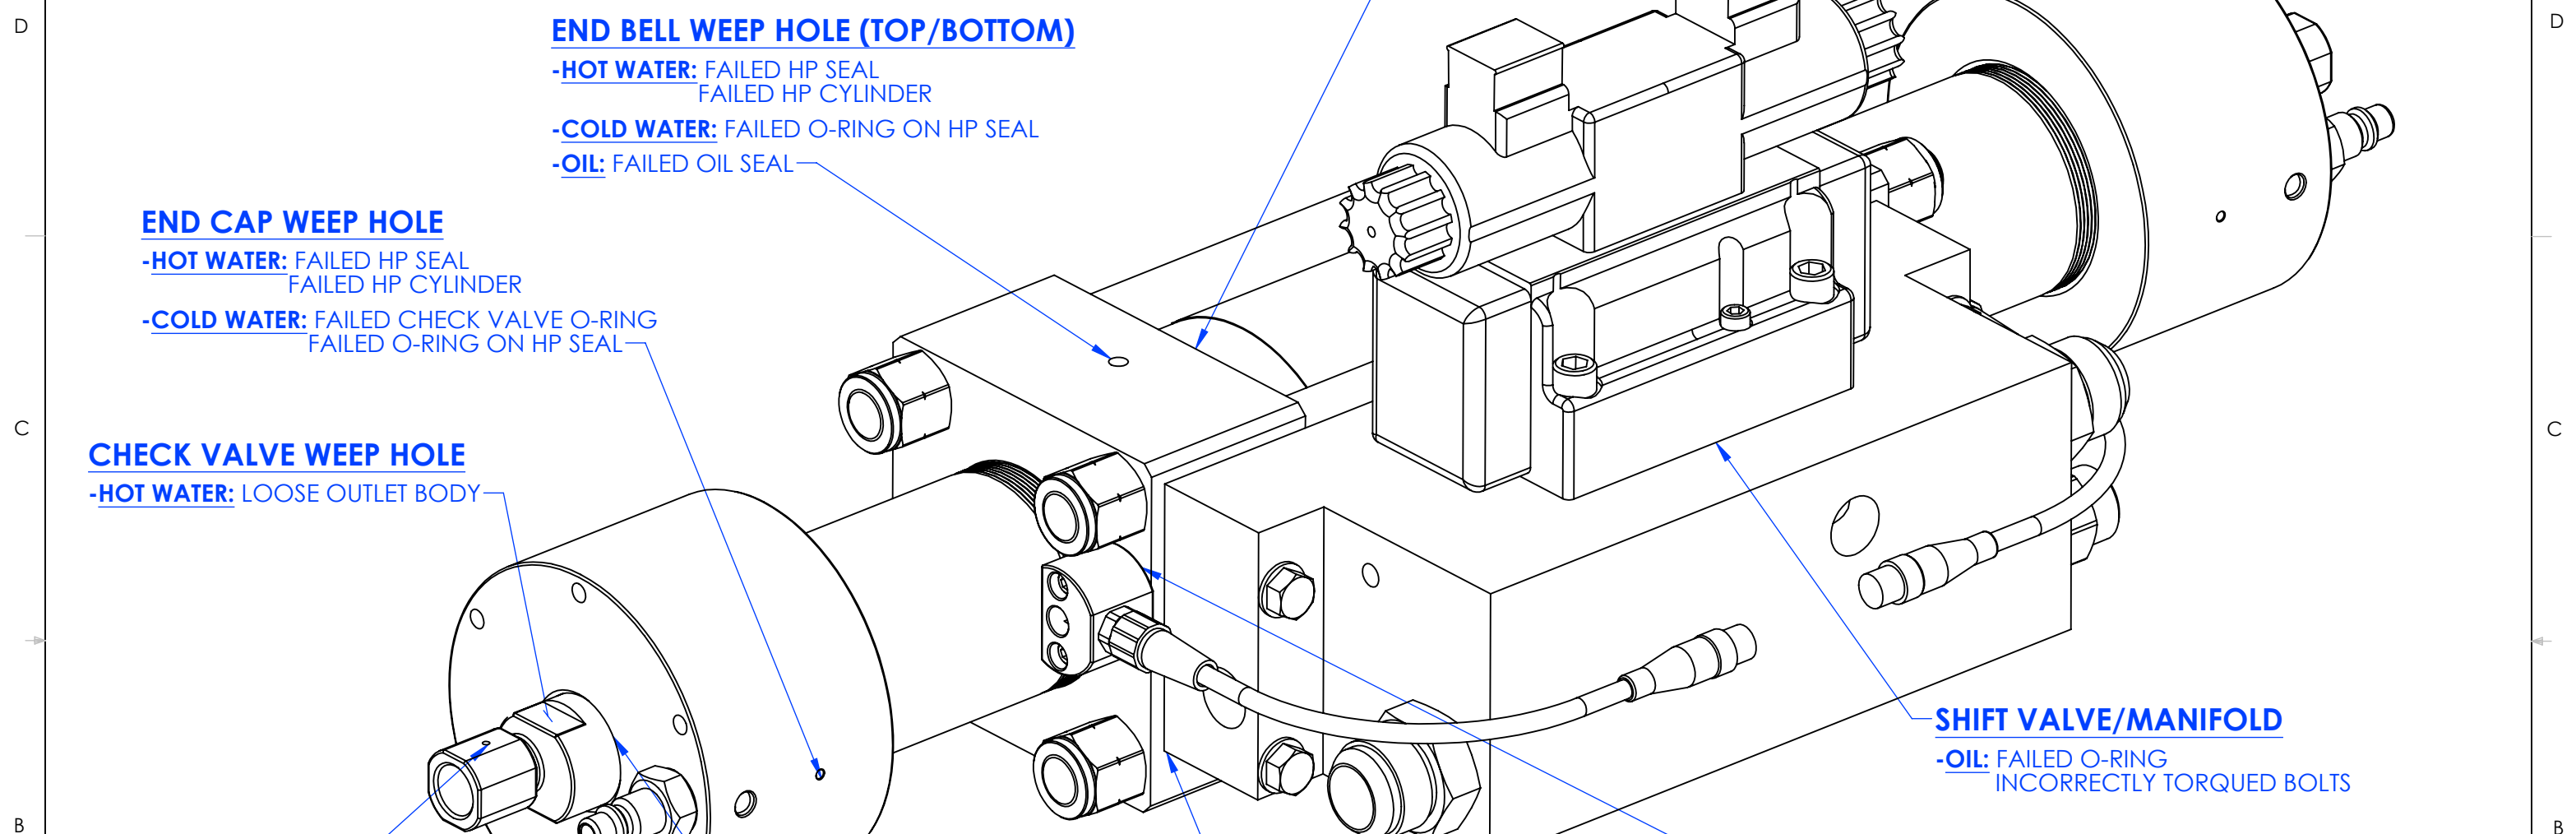
END BELL/CYLINDER INTERFACE

-OIL: PINCHED OR FAILED O-RING
INCORRECTLY TORQUED TIE ROD

END BELL WEEP HOLE (TOP/BOTTOM)

-HOT WATER: FAILED HP SEAL
FAILED HP CYLINDER
-COLD WATER: FAILED O-RING ON HP SEAL
-OIL: FAILED OIL SEAL

END CAP WEEP HOLE

-HOT WATER: FAILED HP SEAL
FAILED HP CYLINDER
-COLD WATER: FAILED CHECK VALVE O-RING
FAILED O-RING ON HP SEAL

CHECK VALVE WEEP HOLE

-HOT WATER: LOOSE OUTLET BODY

SHIFT VALVE/MANIFOLD

-OIL: FAILED O-RING
INCORRECTLY TORQUED BOLTS

SHIFT SENSOR

MANIFOLD/END BELL

-OIL: FAILED O-RING
INCORRECTLY TORQUED BOLTS
END BELLS NOT PROPERLY ALIGNED

END CAP/CHECK VALVE INTERFACE

-COLD WATER: FAILED CHECK VALVE O-RING

OUTLET BODY WEEP HOLE

-HOT WATER: LOOSE HP FITTING
FAILED CONE SEAT ON HP TUBING
-HOT TO TOUCH: FAILED OUTLET CHECK VALVE

LOW PRESSURE WATER LINES

-WARM/PULSING TO TOUCH: LEAKING INLET CHECK VALVE
